Manhole Inspection Summary

Manhole # S13AA_073MH

Insp Date: **7/14/09 11:29 AM**

Location Address: **2811 MOSHER ST**

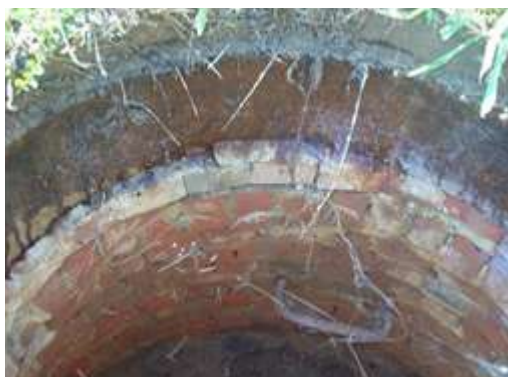
Defect 1

Frame Offset: **1** (in.) Condition: ☒ Sound ☐ Cracked ☐ Leaks

OFFSET FRAME

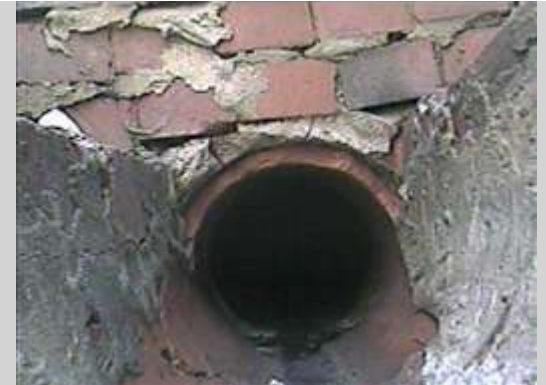
12 O'Clock Outflow

8 in. Circular Gravity Sewer
Pipe Out @ 12 O'Clock

Deposits: ☒ None ☐ Mud ☐ Sludge ☐ Debris ☐ Grease

Infiltration: **None** Pipe Seal Cond: **Sound**

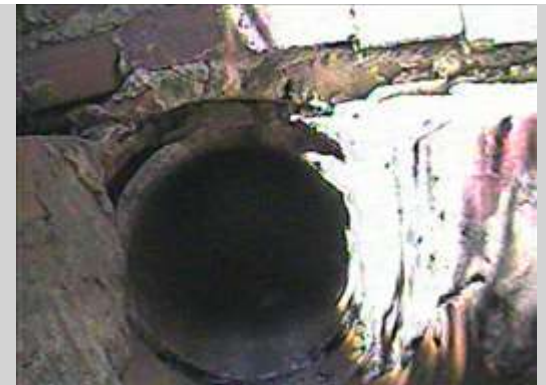
6 O'Clock Inflow

8 in. Circular Gravity Sewer
Pipe In @ 6 O'Clock

Deposits: ☒ None ☐ Mud ☐ Sludge ☐ Debris ☐ Grease

Infiltration: **None** Pipe Seal Cond: **Sound**
